Captain's Response to the Canada Transportation Safety Board's

Marine Investigation Report M10F0003

Regarding the Loss of the Sail Training Vessel *Concordia*

Capt. Bill Curry, December, 2011

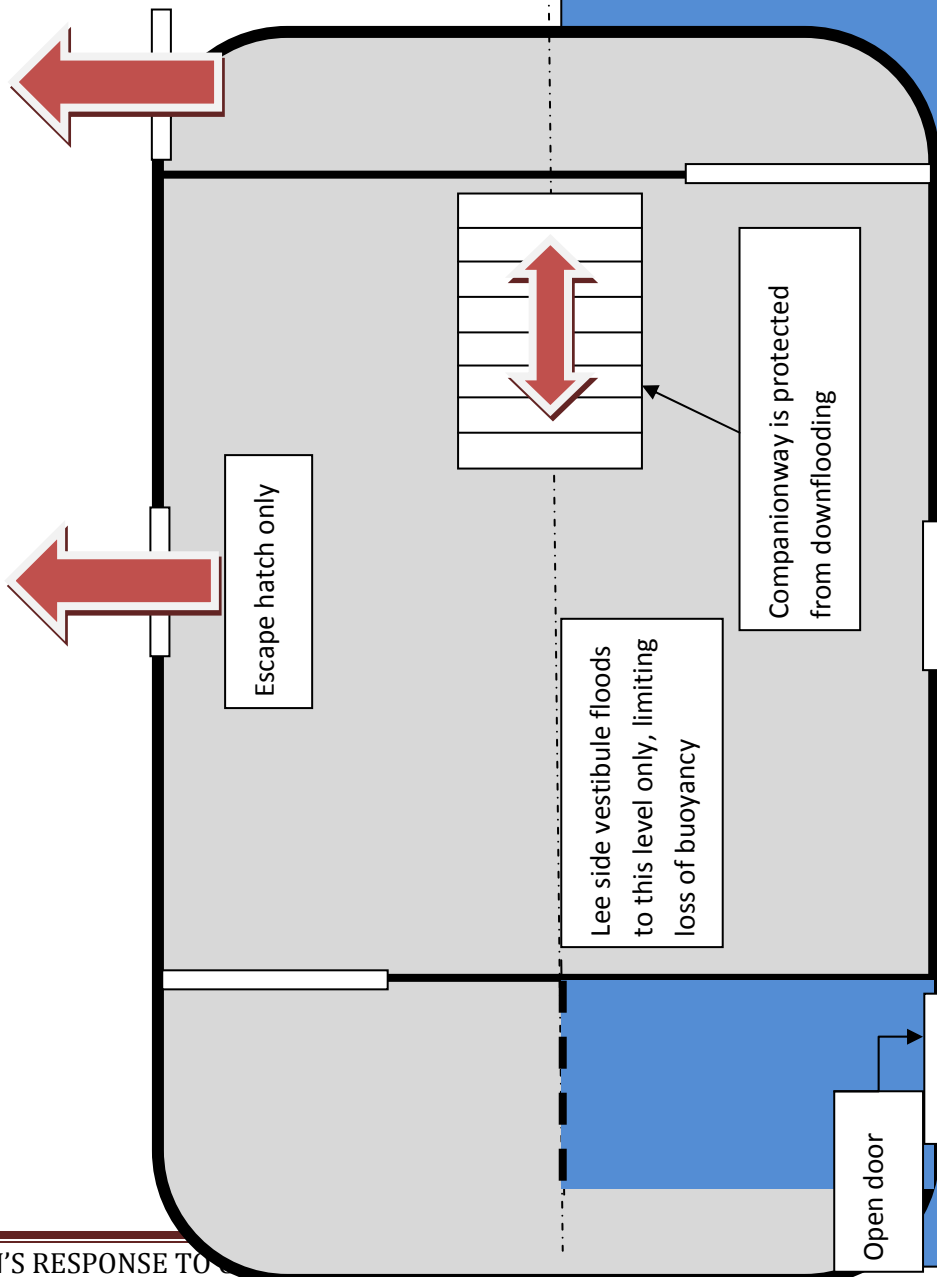
Sketch of Self-protected Deckhouse

Notes: Vestibule bulkheads act as sills to limit flooding. The bulkheads could be fitted with rungs to facilitate evacuation at large angles of heel. Vestibules used for storing foul-weather gear, harnesses, etc.

In my recently acquired opinion, superstructures that are considered essential components of a vessel's stability picture should not be capable of being compromised. This will not happen until designers come up with ways to simultaneously allow for the unencumbered passage of many people while maintaining strict watertight integrity. The *Concordia* met all applicable design standards for ocean-going vessels of her class but events conspired to cause the loss of her deckhouse integrity. I believe most captains and crews are diligent about closing weatherdeck doors when danger is perceived, but they will recognize that in ostensibly fine weather the doors may be open.
